# Township Development, Clarkefield, Victoria: Cultural Heritage Management Plan

Number 16263

APD Projects on Behalf of Clarkefield Developments Pty Ltd.

25 March 2021

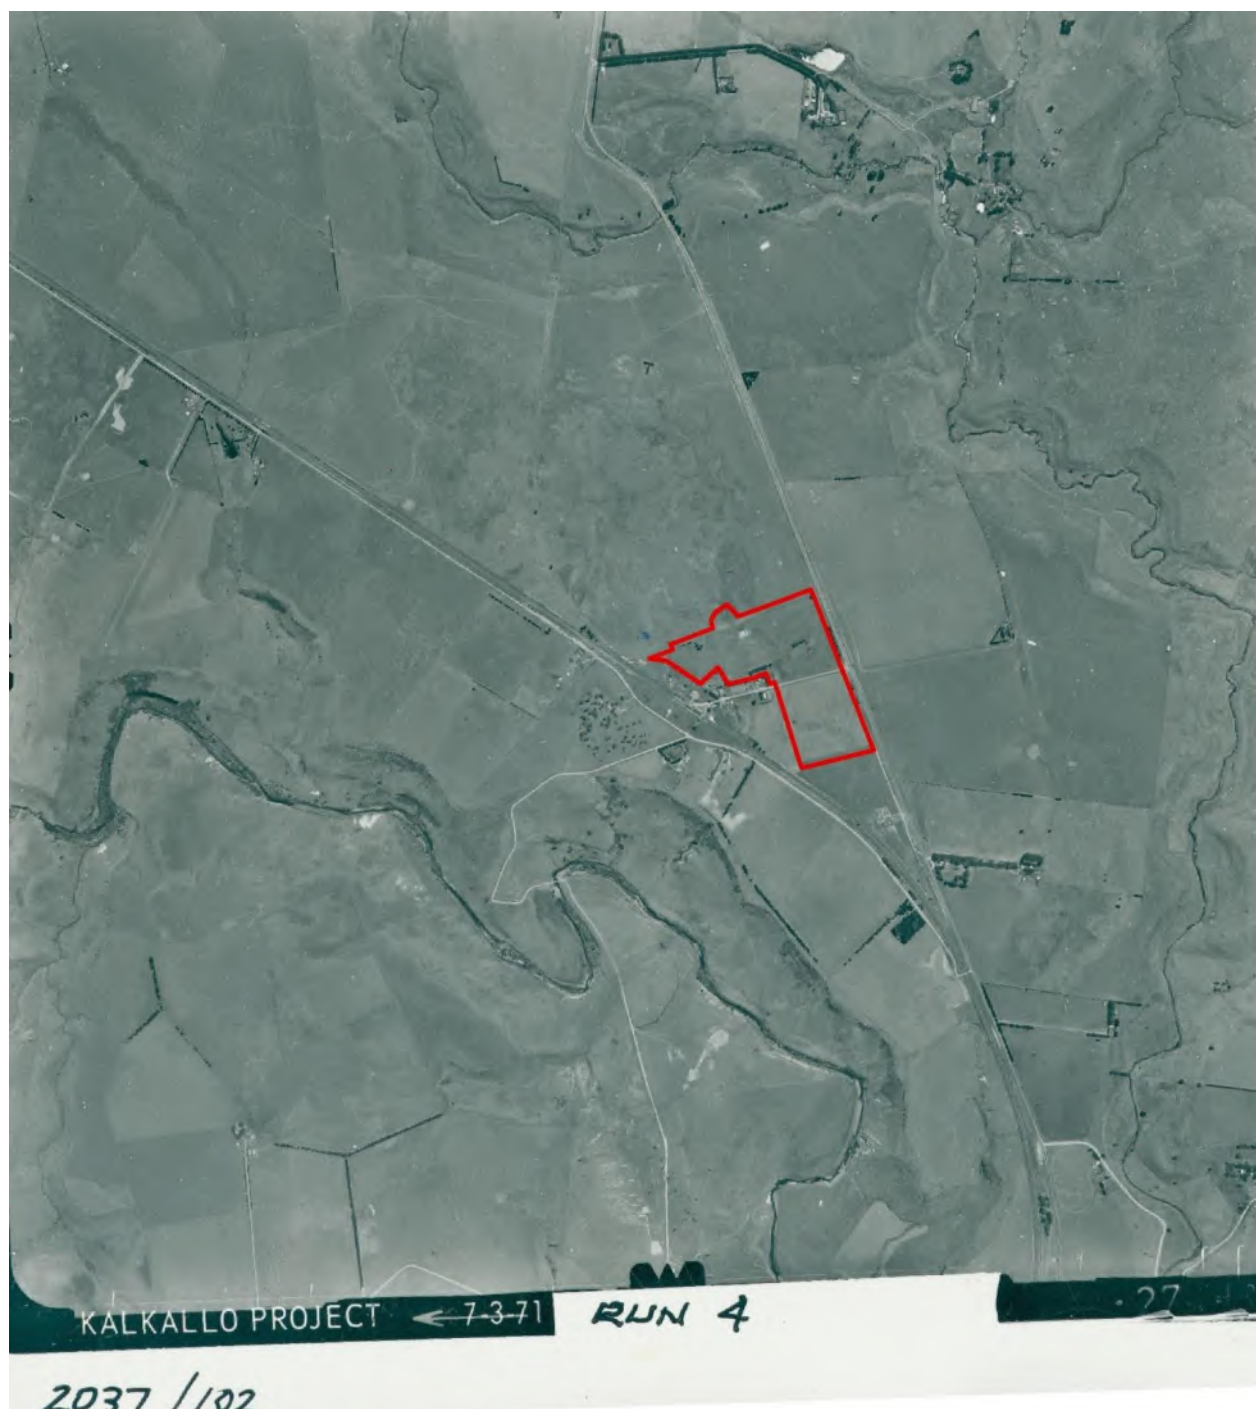
Figure 2: View of Activity area (indicated in red outline) in 1971 (LandData 2019)

Examination of satellite imagery, such as those found on LandData, indicate that the land in and around the activity area has been predominantly used for agricultural purposes, with residential occupation occurring in the Clarkefield township since the nineteenth century (Figure 2). The settlement is immediately adjacent to the activity area. Given its specific land use history, it is likely that the activity would have been used primarily for agricultural purposes since the arrival of Europeans to the region.

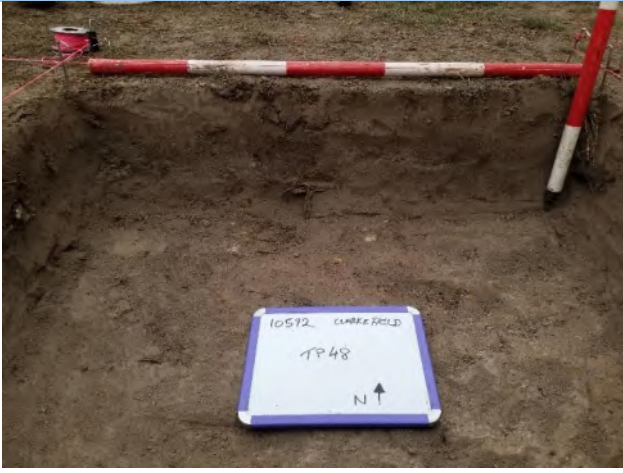
| TP (SW) Coordinates | Stratigraphic Profile | Stratigraphic Description |
|---|---|---|
| E<br>301492.8742<br>N<br>5848607.135<br>(GDA 94,<br>Zone 55) | <p style="text-align: center;"><b>TP48 – Volcanic Plains</b></p> <p style="text-align: center;">TP48 West Profile</p> <p style="text-align: center;"><b>Figure 3: Stratigraphic Profile of TP48</b></p> | <p><i>Context 1:</i> 0 to 210 mm: Medium grey friable dry fine silt. Inclusions: None. No artefacts. Munsell 10YR 5/2, pH 7.</p> <p><i>Context 2:</i> 210 to 260 mm: light brownish grey compacted moist fine clay. Inclusions: Moderate frequency of small to medium sized basalt. No artefacts. Munsell 10YR 5/2, pH 7.</p> |
| 1 x 1 m | <p><b>Plate 5: Stratigraphy of TP48 north section (photograph by Albert Francis)</b></p> | No artefacts present |
